Background Details

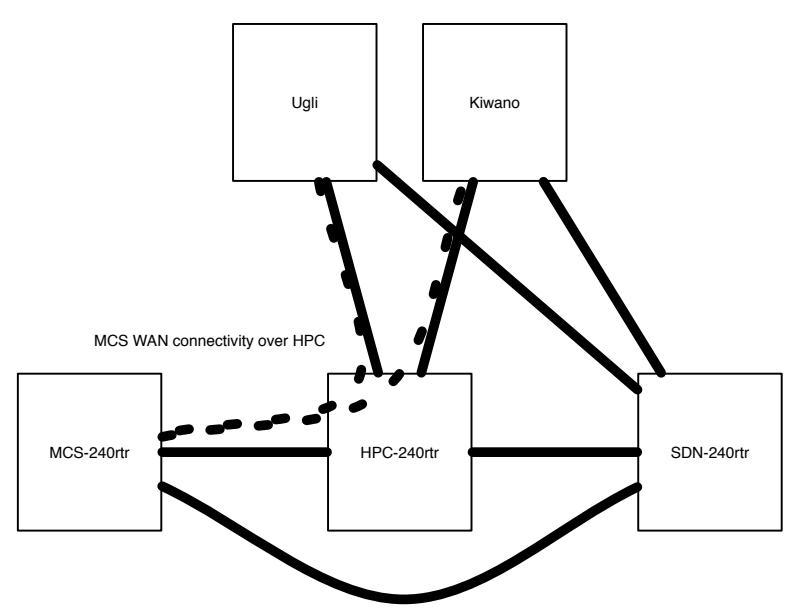
On Tuesday, March 4, 2014, work was undertaken to remove the HPC router from the network. The initial state can be seen in this drawing:

Two things of note in this drawing is the reliance on HPC by MCS for access to the border routers. Additionally, the full routing mesh between the three devices: MCS, HPC and SDN. During the conversion process, the links from the border routers that terminated on HPC were migrated to MCS. This was done one at a time, allowing for the network to gracefully move traffic from one interface to the other. The network components were reused. This included cables and optics that had been in production since we moved into the space. Additionally, the virtual components, VLANs, networks, etc were also reused to make the transition seamless. Finally, all Layer 3 capabilities in HPC were disabled allowing the box to play a role as a simple switch, thereby simplifying the infrastructure.

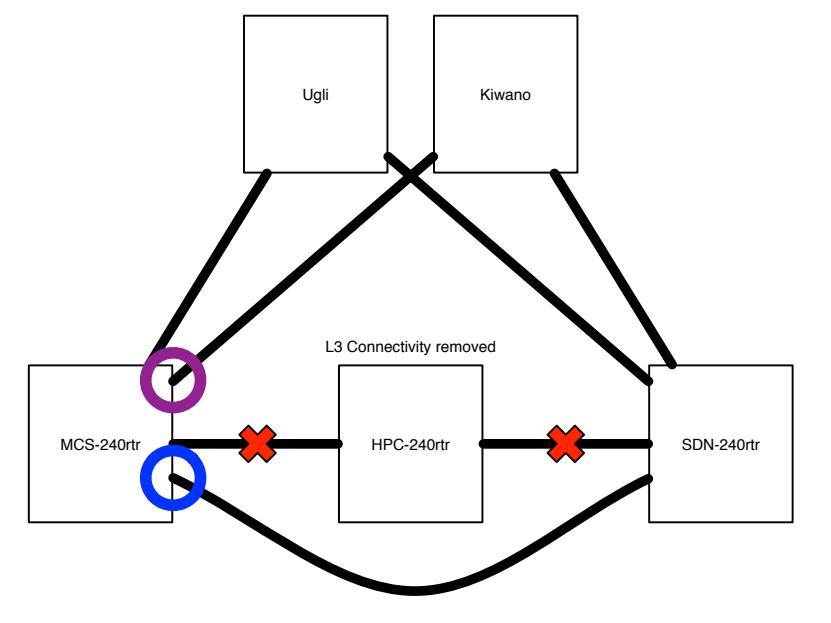
The final state of the network can be seen in this drawing:

Two points of note here. The first is the blue circle. This represents the first outage affecting traffic travelling from MCS connected networks, i.e. routed on mcs-240rtr, particularly ALCF desktop net, towards SDN. The second is represented by the purple circle. This represents the second outage affecting traffic flowing in or out of the MCS connected networks, including traffic between 240 Server net and 221 Server net. These outages will be dissected in the following sections.

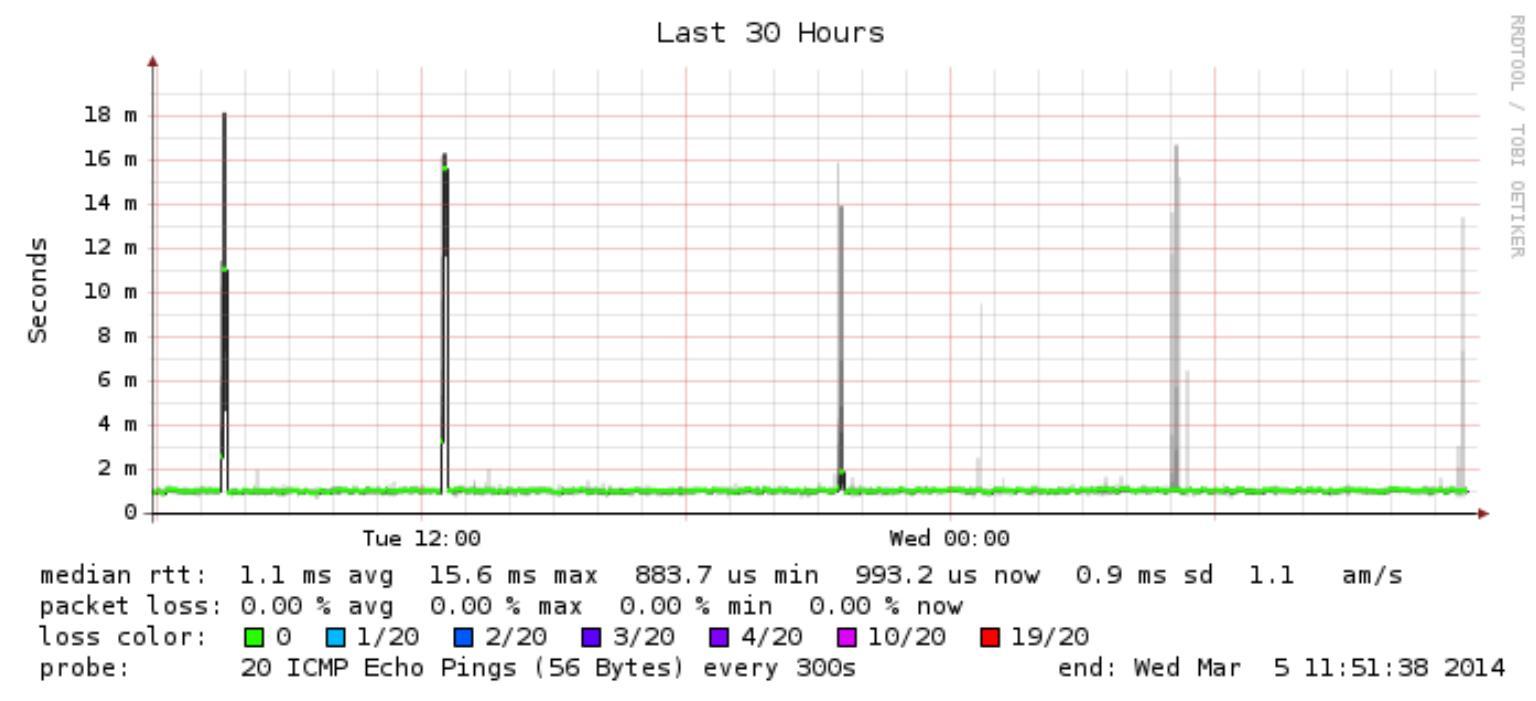
During the outage, smokeping was reference to identify if there was loss or incurred delay inconsistent with the historical record. Looking at the graphs for the main MCS web server showed no issues or changes

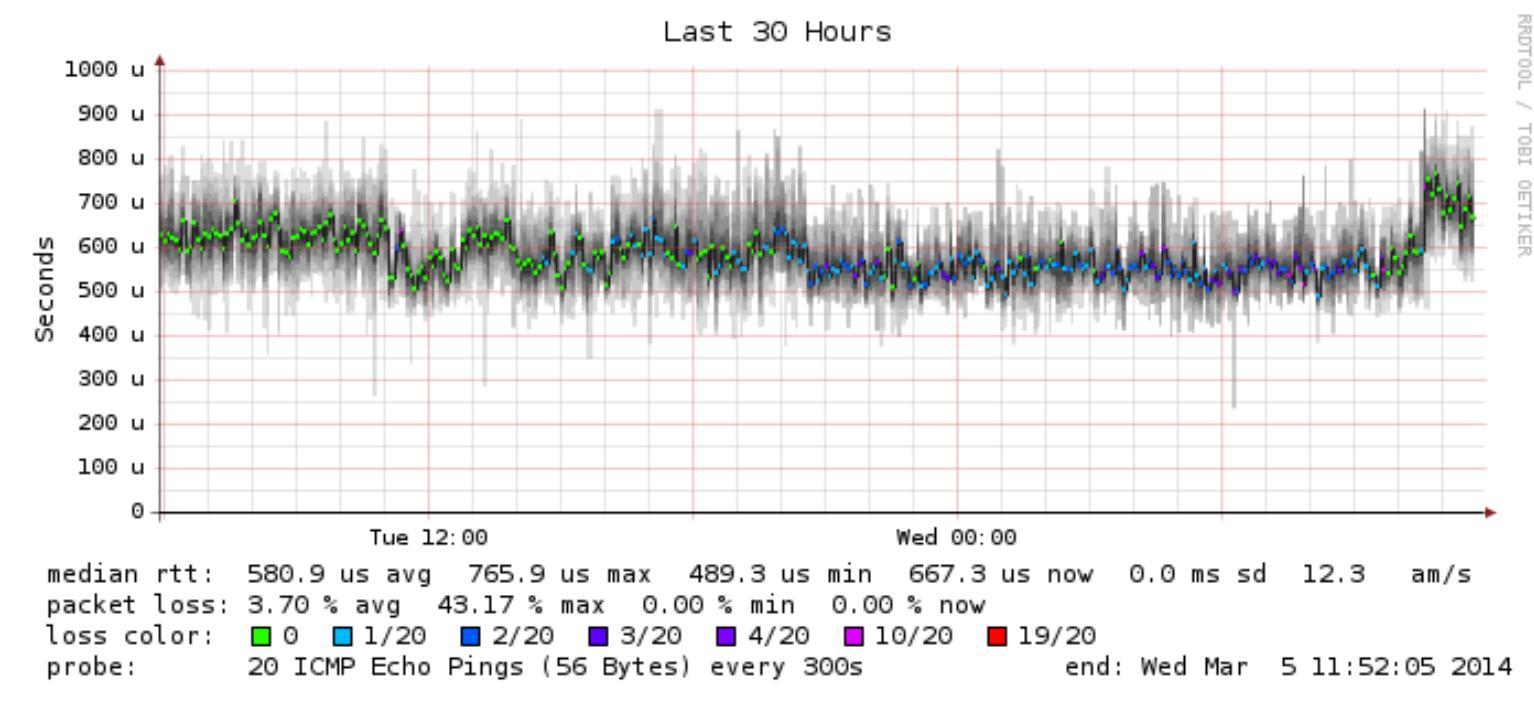
At this point, we moved on to other testing points and troubleshooting steps. In doing so, we missed graphs like this (showing performance of one of the login servers):

There is no indication in change of latency, but there is a 30-50% packet loss event starting in the correct time window and lasting until the remediation steps were put in place. Another example:
